# Using Remote Sensing Tools to Target Stream Protection and Wastewater Treatment BMPs in Rural Kentucky

**Barry Topping, Tetra Tech**

# Project Background

## ► Hinkston Creek Watershed Based Plan

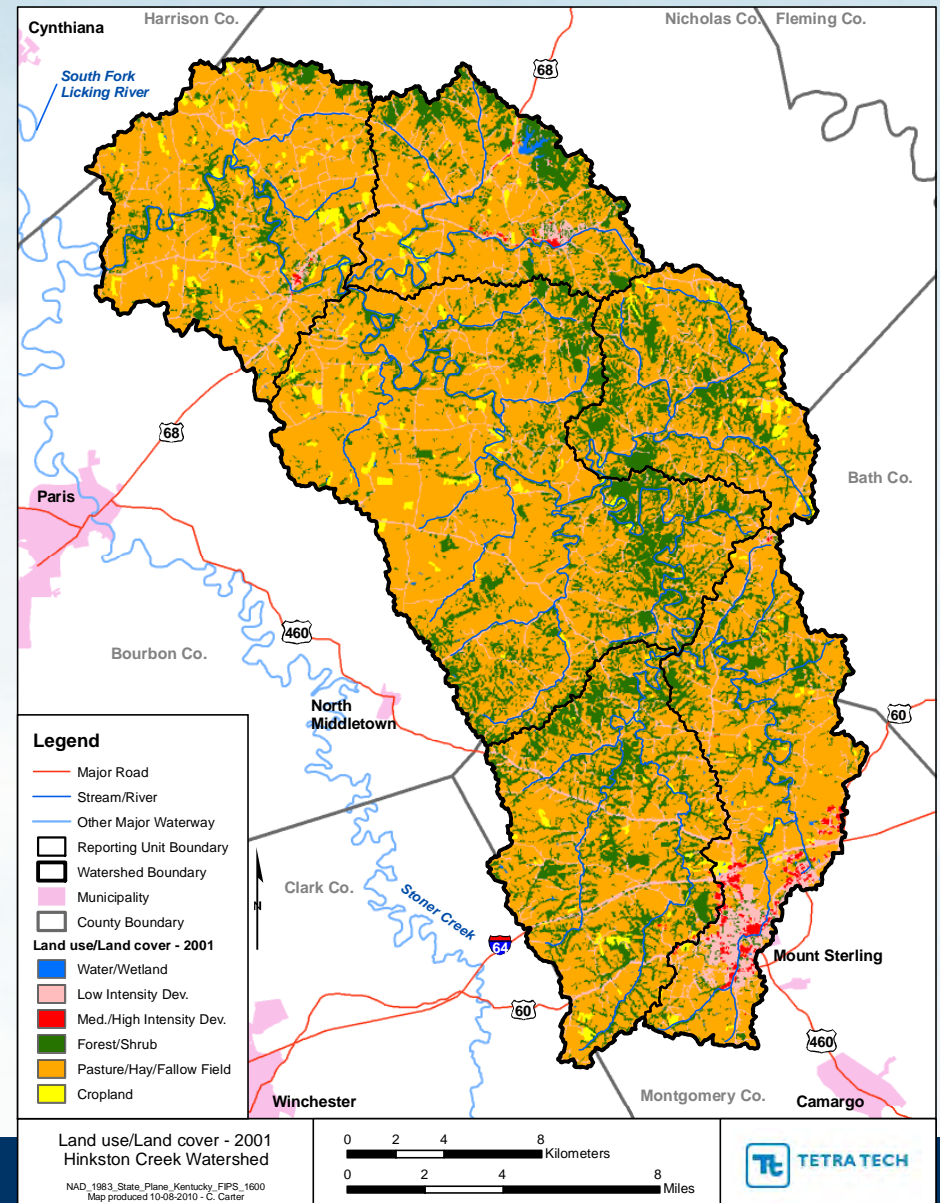
# Hinkston Creek Watershed

- ▶ Located in east central Kentucky
- ▶ 260 mi<sup>2</sup>
- ▶ Land Use Land Cover:
  - 72% pasture/cropland
  - 20% forest/shrub
  - 8% developed
- ▶ <1 percent high intensity development
- ▶ Primary urban center is Mt. Sterling (pop. = 6800)

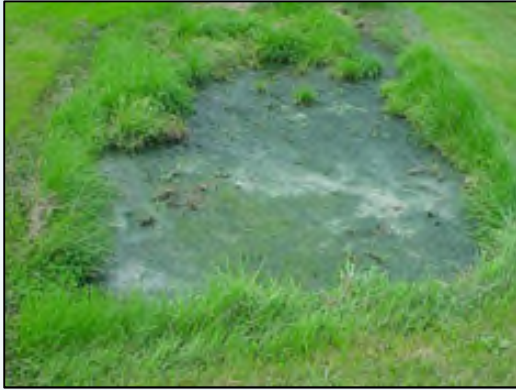
Onsite wastewater system  
risk analysis

# Onsite Wastewater System Risk Analysis

- Malfunctioning septic systems are a concern for nonpoint source (NPS) pollution in the watershed

- ▶ Areas of interest:
  - Exclude publicly serviced areas
  - Include areas within 1-2 miles of publicly serviced areas where >1house/acre
- ▶ Spatial attributes:
  - Household density
  - Closeness to streams
  - Closeness to karst topography

- ▶ Prioritization and Results
  - Applied equal weight to each of the three attributes
  - Areas with highest potential to contribute NPS pollution to streams and/or near-surface groundwater
- ▶ Subsequent analyses
- ▶ Target for management

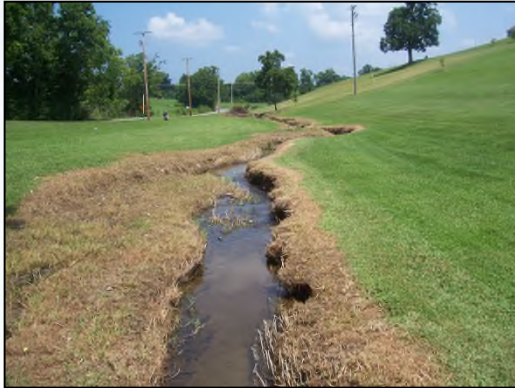
Riparian buffer assessment  
and deficiency analysis

- Analysis of riparian buffer deficiency served as a method for identifying riparian areas throughout the watershed that were either intact or impacted

- ▶ Area of interest:
  - Riparian areas
  - 50 or 100-ft stream buffer
- ▶ Spatial attributes:
  - Riparian buffer health status
    - Impacted = impacted land use type, <30% canopy cover
    - Intact = >30% canopy cover

$$\text{Percent impacted buffer} = \text{Buffer deficiency}$$

Watershed-wide:  
75% deficient

Subwatershed level:  
45 to 100% deficient

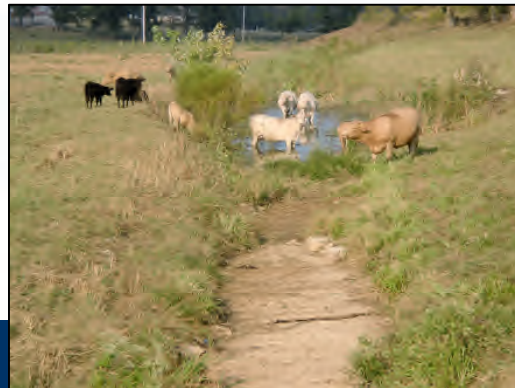
High-risk stream  
channel assessment

- ▶ In a watershed with  $>90\%$  riparian buffer deficiency, it is often a challenge to target initial management efforts

- Overlaid aerial imagery with riparian deficiency
- Visually scanned impacted reaches
- Assessed the intensity of impact on riparian areas based on the landcover context of the riparian buffer

- ▶ Impacted riparian areas were divided into four levels of impact based on stress conditions observable from the aerial imagery

- Proximity of intense tilling and/or grazing to the stream edge
- Evidence of cattle access points
- Lack of tree or shrub cover in the riparian buffer

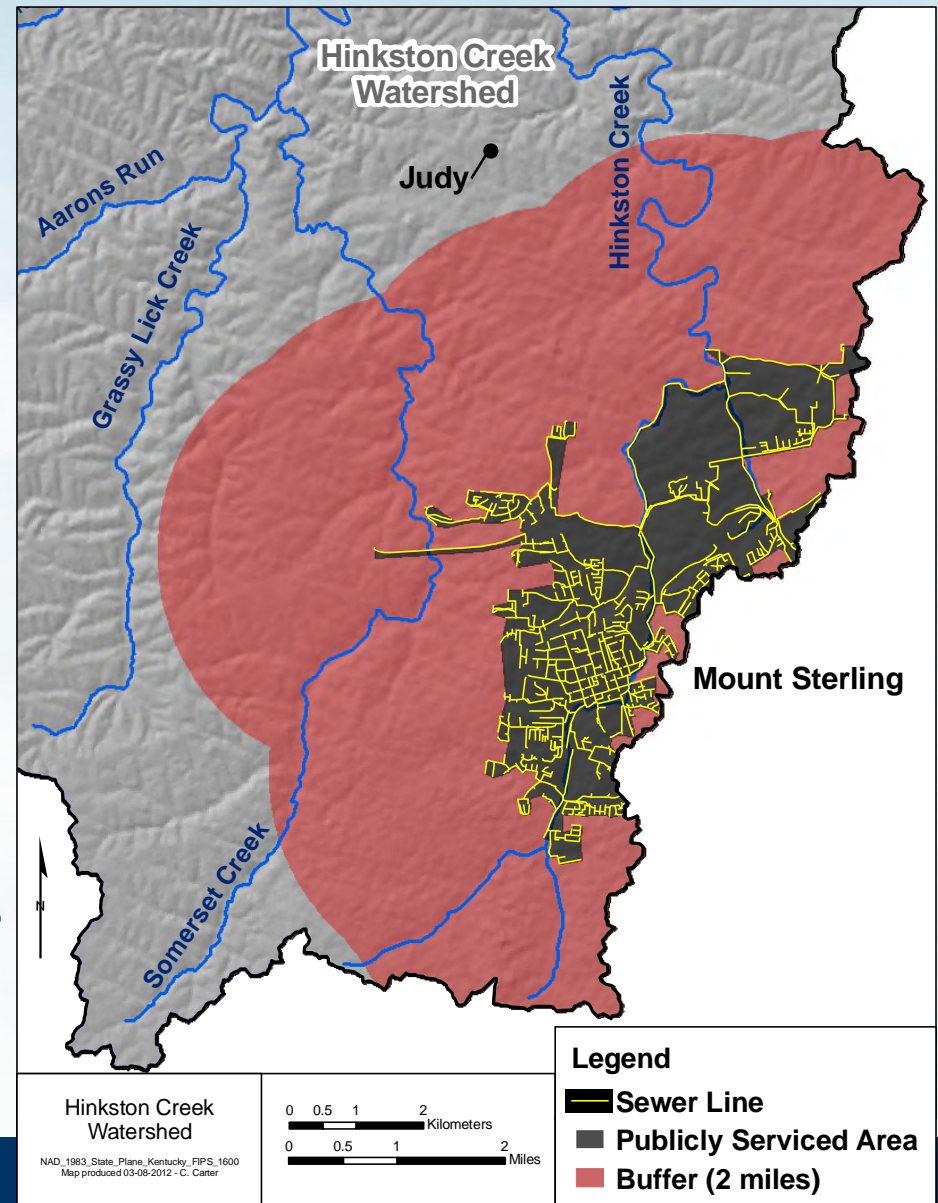
# Onsite Wastewater System Risk Analysis

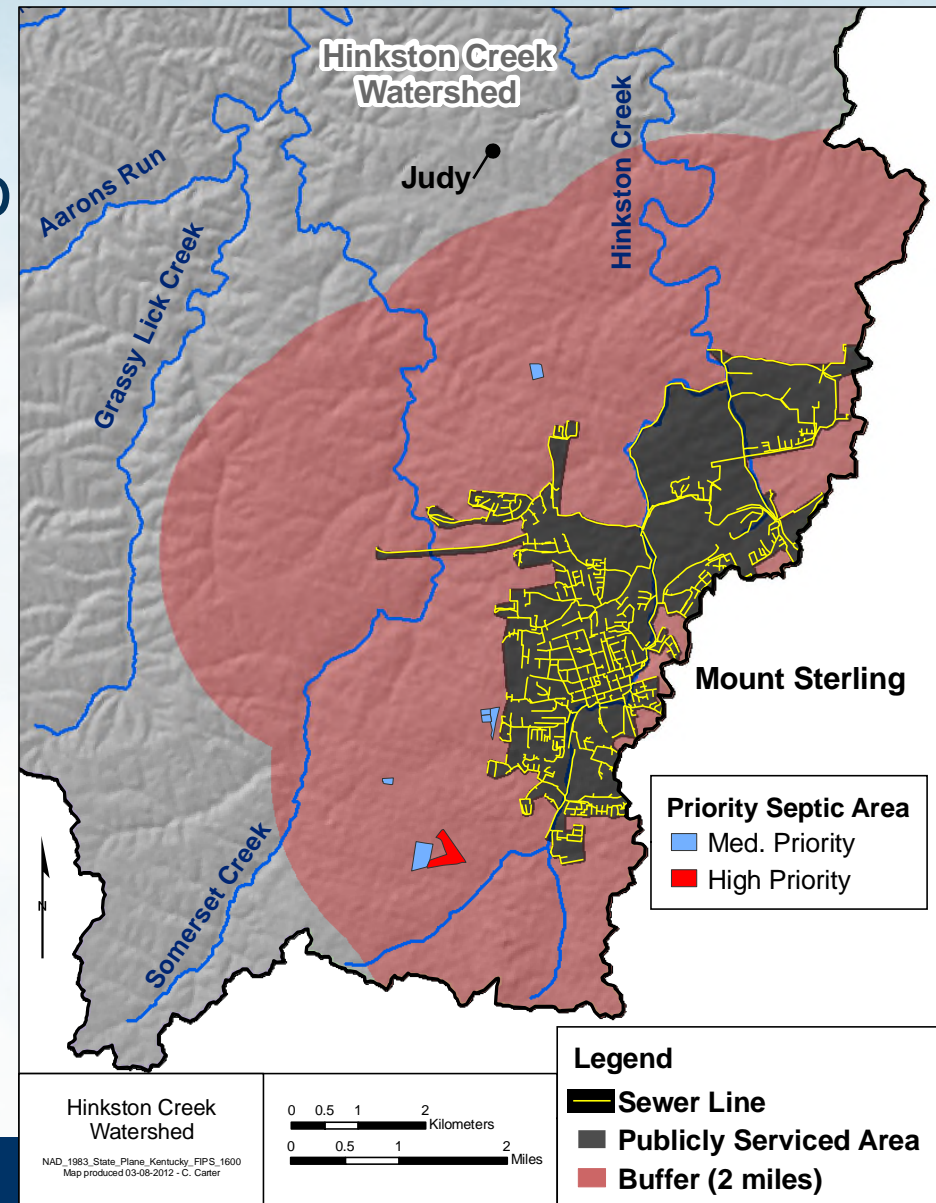
# Onsite Wastewater System Risk Analysis

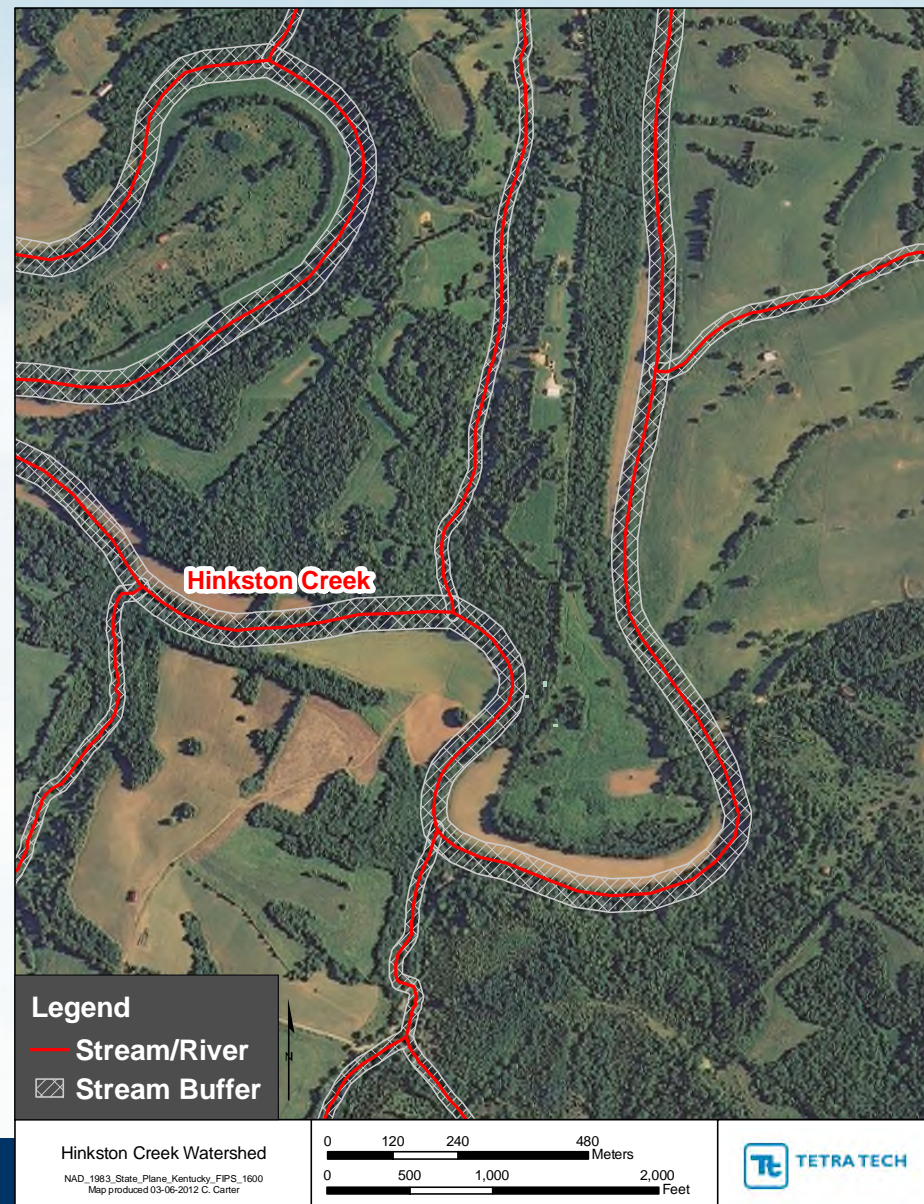
# Riparian Buffer Assessment and Deficiency Analysis

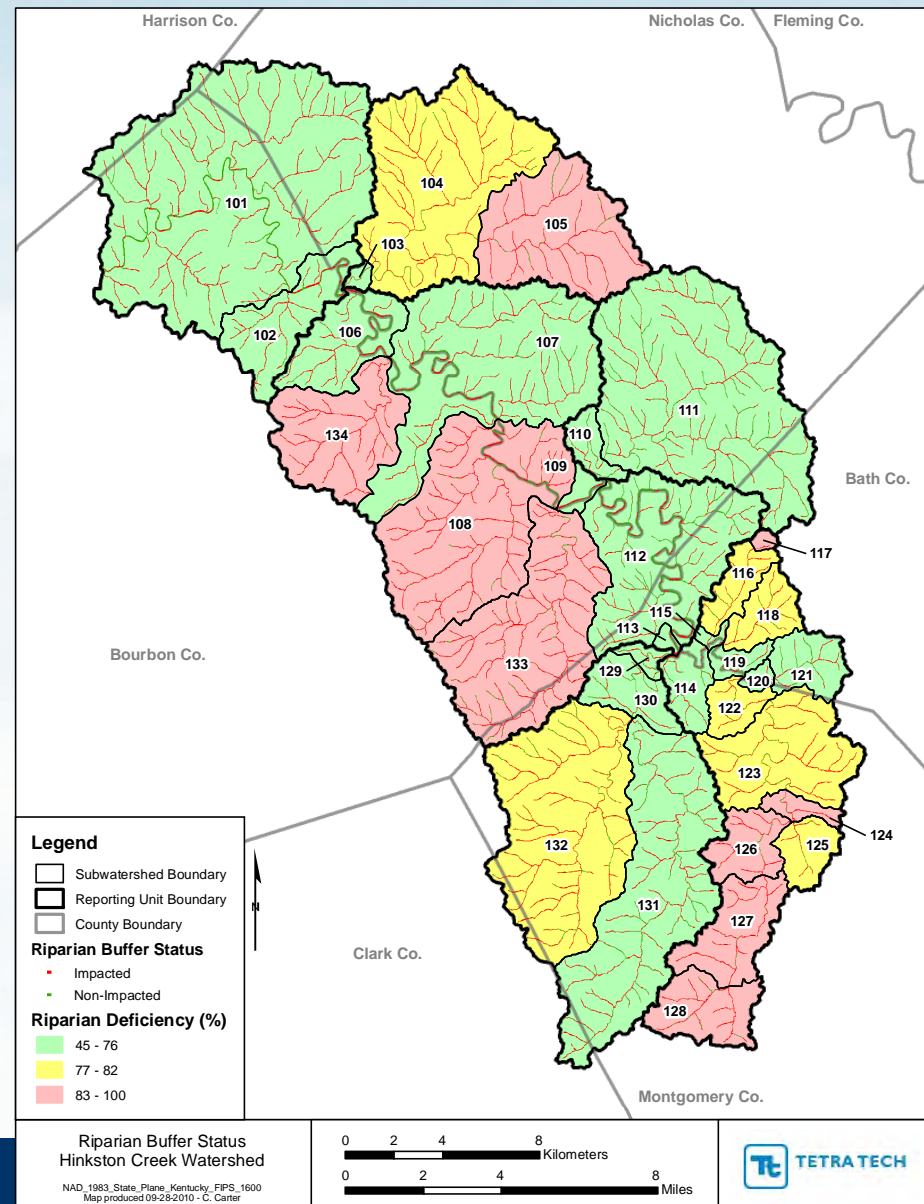
# Riparian Buffer Assessment and Deficiency Analysis

## ► Results

## ► Highlight subwatersheds of greatest concern for impacted riparian buffers

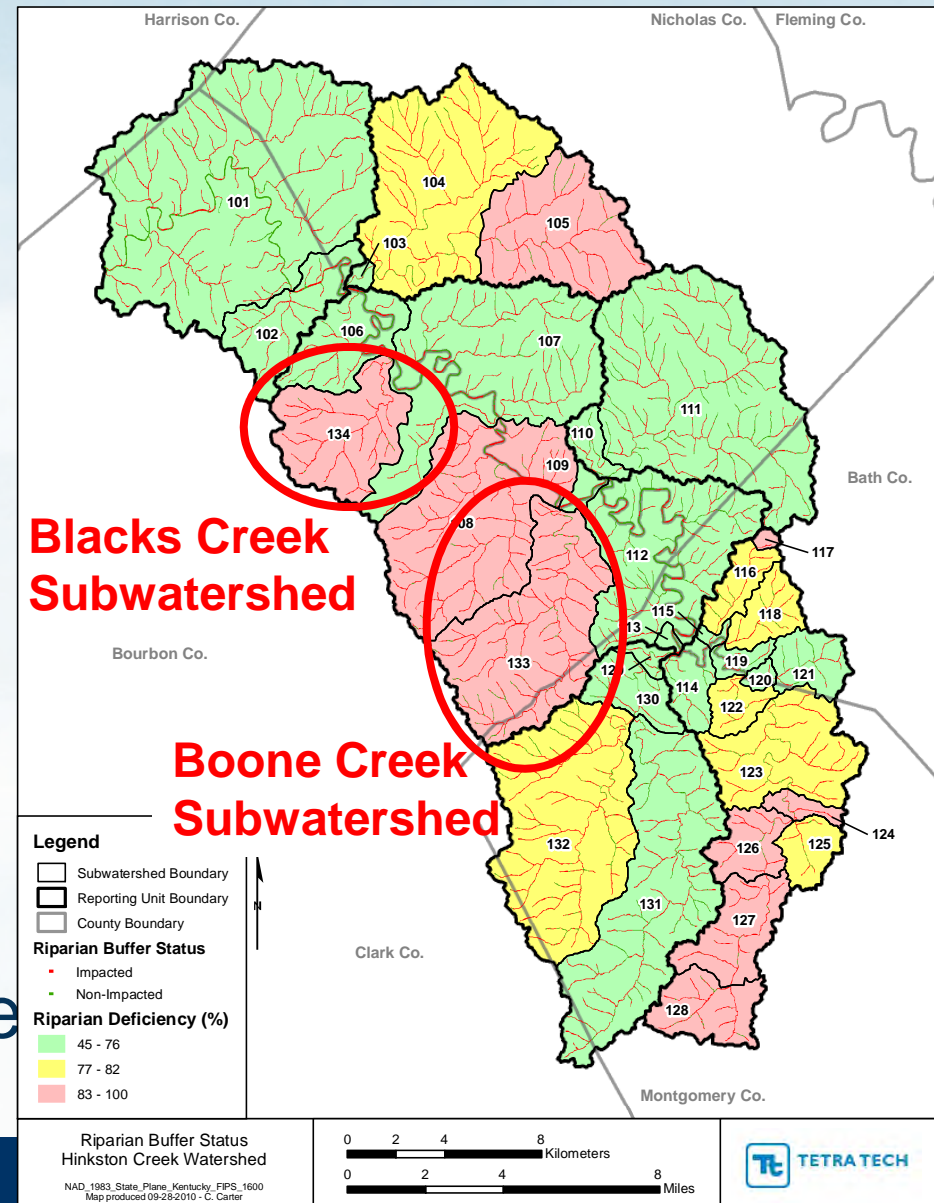
# High-risk Stream Channel Assessment

## ► Area of interest:

- 2 subwatersheds, with >80% buffer deficiency

## ► Tailored analysis:

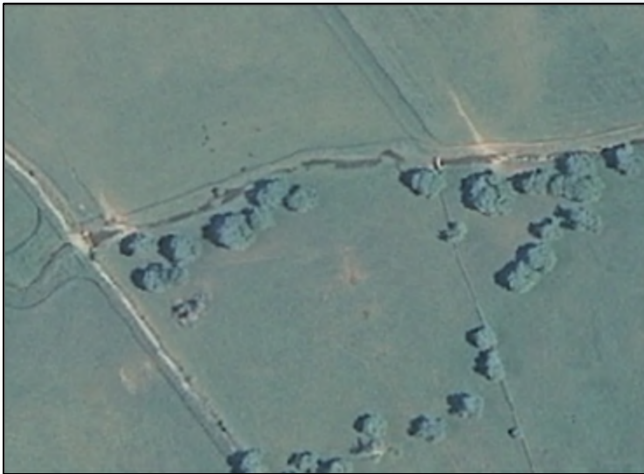
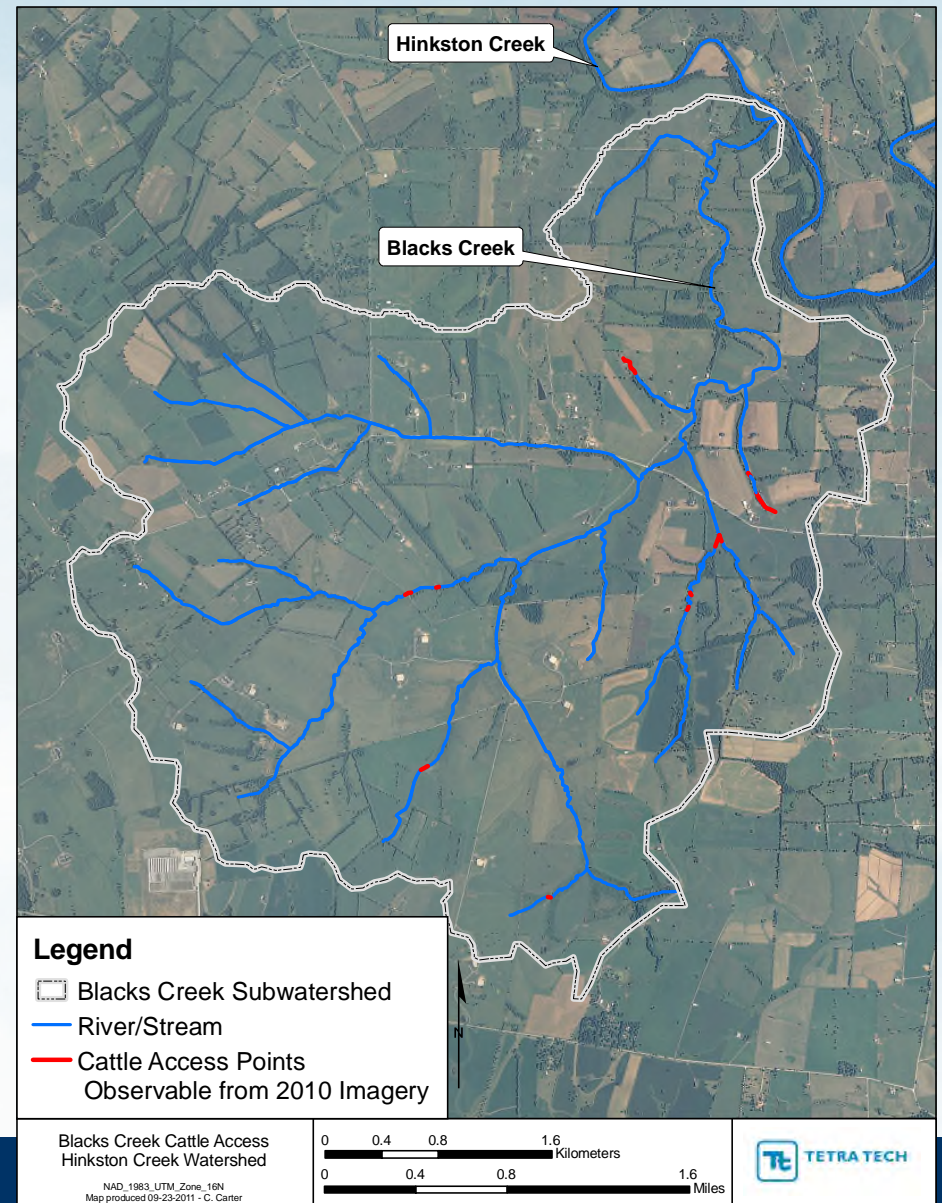
# High-risk Stream Channel Assessment

- ▶ Cattle access points
  - Visible along some reach segments from the aerial imagery
  - Evidence of bare stream or pond bank

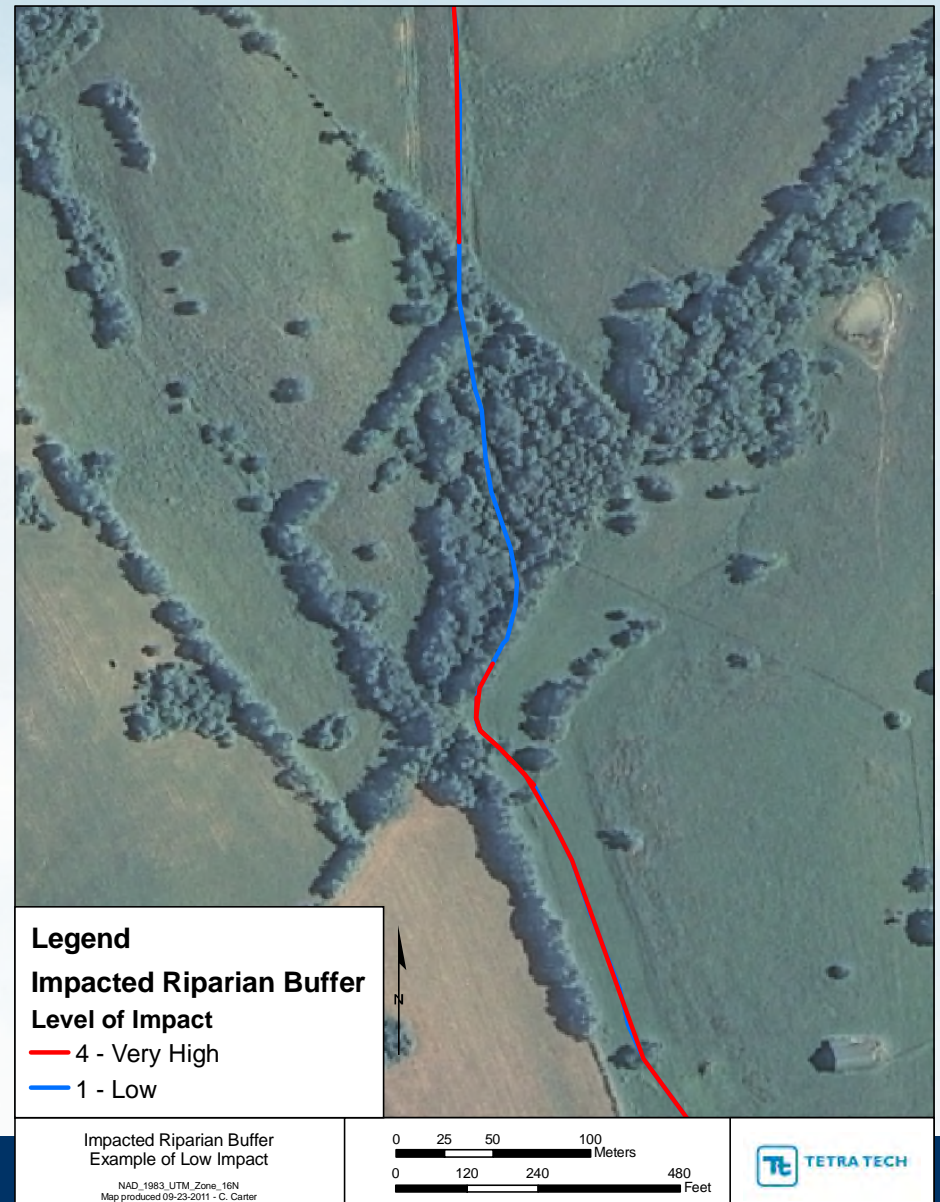
- Low level of impact (Level 1)

Level of Impact	Definition
1	Low <sup>1</sup> – Reaches that appear to be under low stress conditions. There is observable evidence of riparian protection consisting of tree lines or considerable scrub/shrub areas along both sides of the stream and/or evidence of intense tilling and/or grazing is an acceptable distance from stream edges.
2	Moderate - Reaches that appear to be under slightly stressed conditions and are surrounded by agricultural areas but there is observable evidence of riparian protection. Evidence of riparian protection consists of an observable tree line or scrub/shrub area along at least one side of the stream and/or intense tilling and/or grazing do not appear to be directly adjacent to stream edges.
3	High - Reaches that appear to be under moderately stressed conditions and are surrounded by agricultural areas but there is some observable evidence of riparian protection. Evidence of riparian protection consists of an observable fence line and/or intense tilling and/or grazing do not appear to be directly adjacent to stream edges.

<sup>1</sup>Reaches identified as having a low level of impact may have sources of impact that are not visible from aerial imagery, such as cattle access points that are under the tree canopy. Ground truthing is strongly recommended for these reaches to ensure the correct level of impact has been captured.

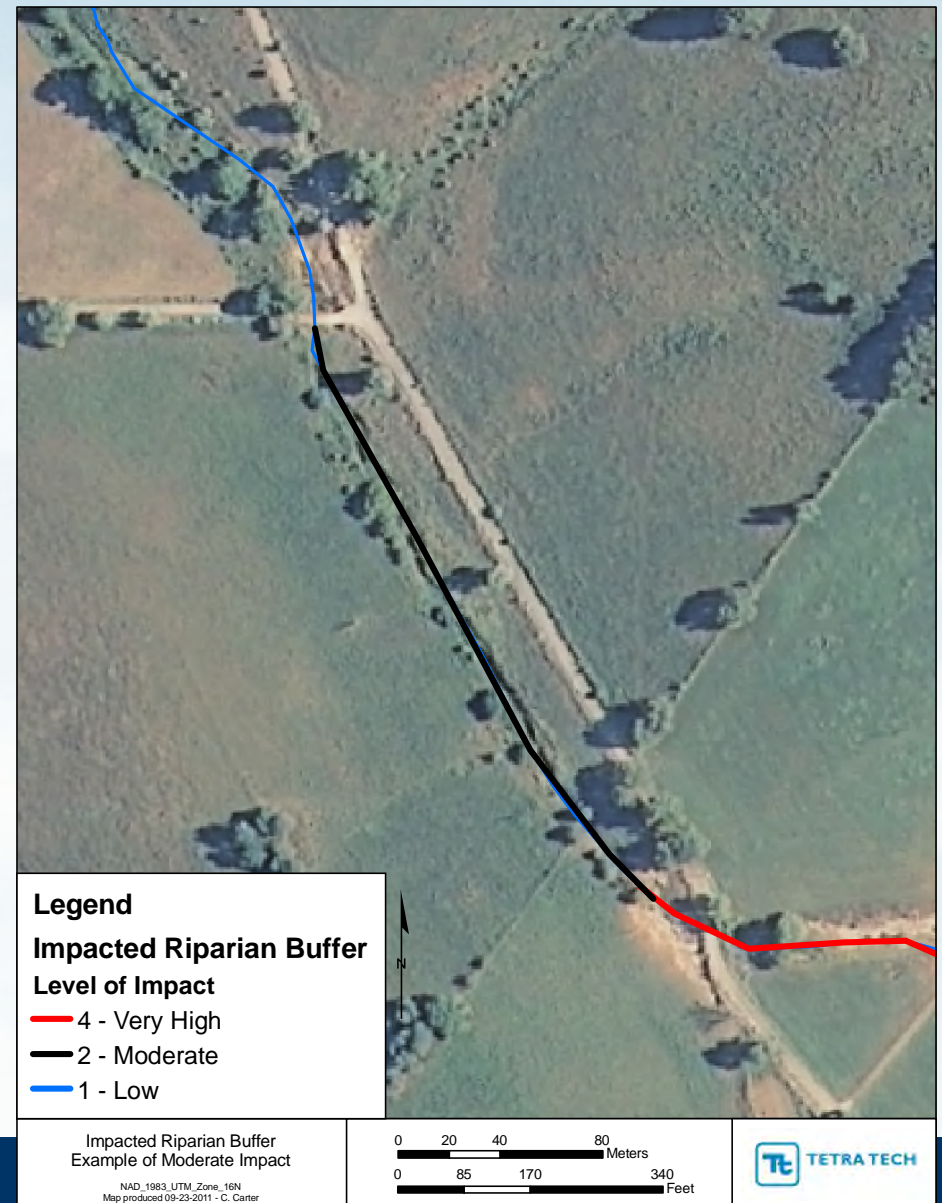
- Moderate level of impact (Level 2)

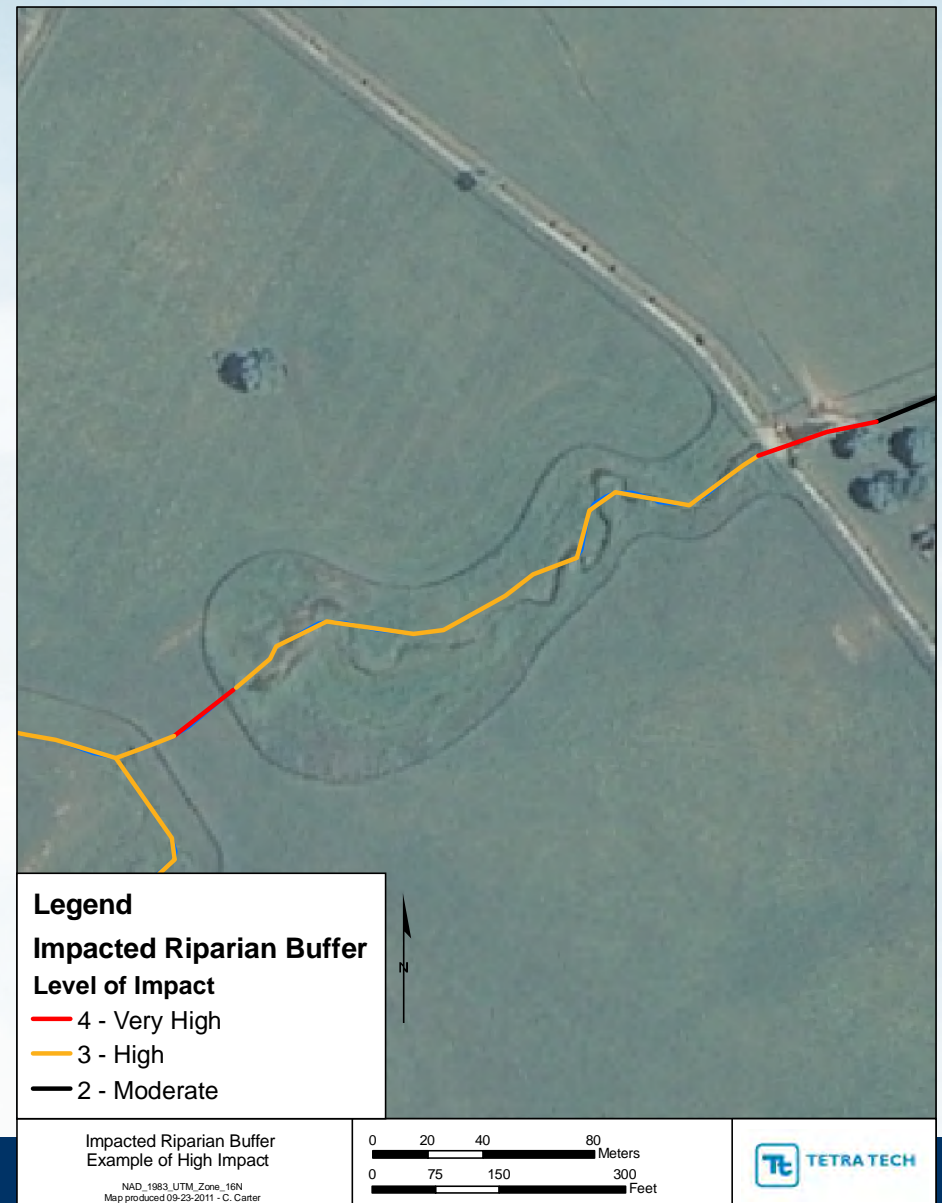
- High level of impact (Level 3)

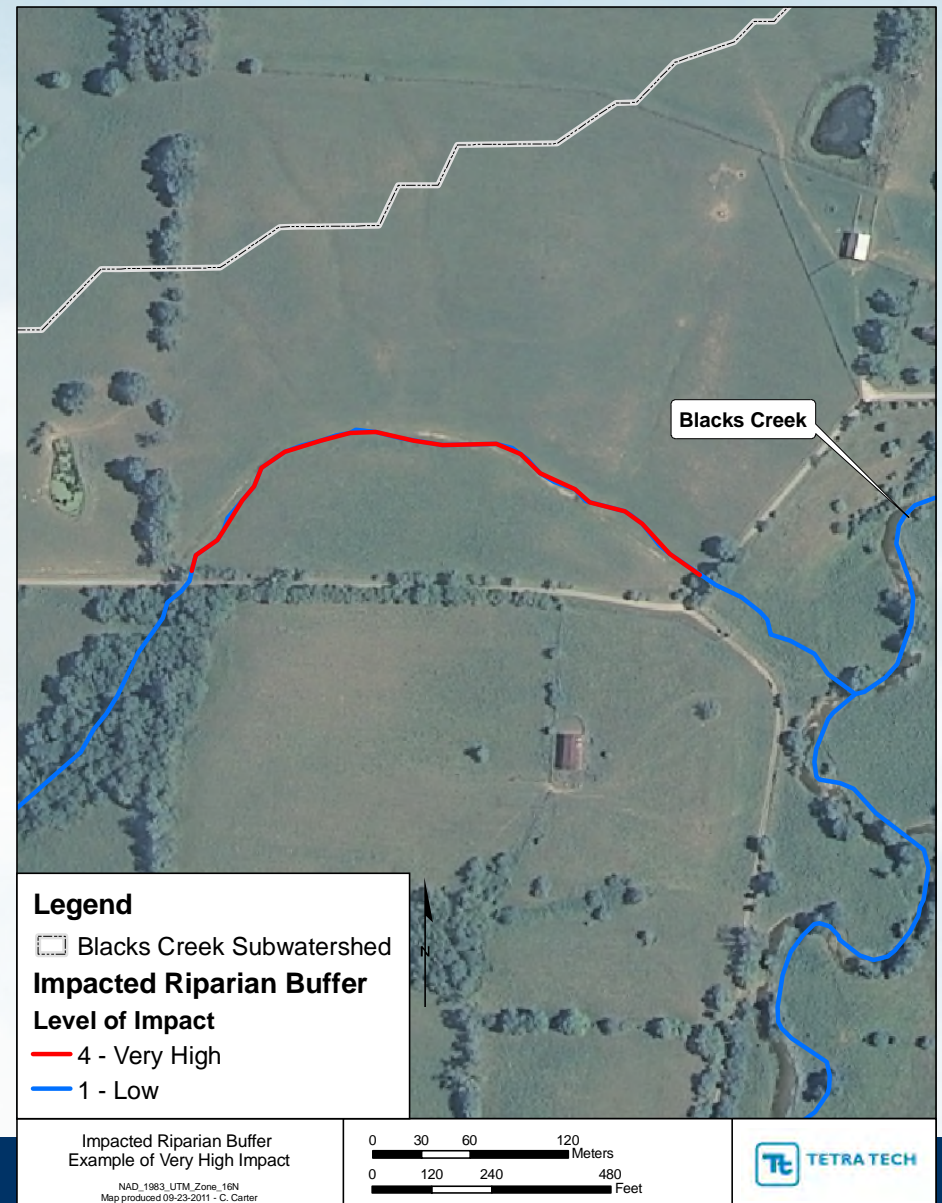
- Very High level of impact (Level 4)

4	Very High - Reaches that appear to be under severely stressed conditions and are surrounded by agricultural areas; there is no apparent riparian protection. Intense tilling and/or grazing are directly adjacent to stream edges and/or there is a noticeable cattle access point to the stream.

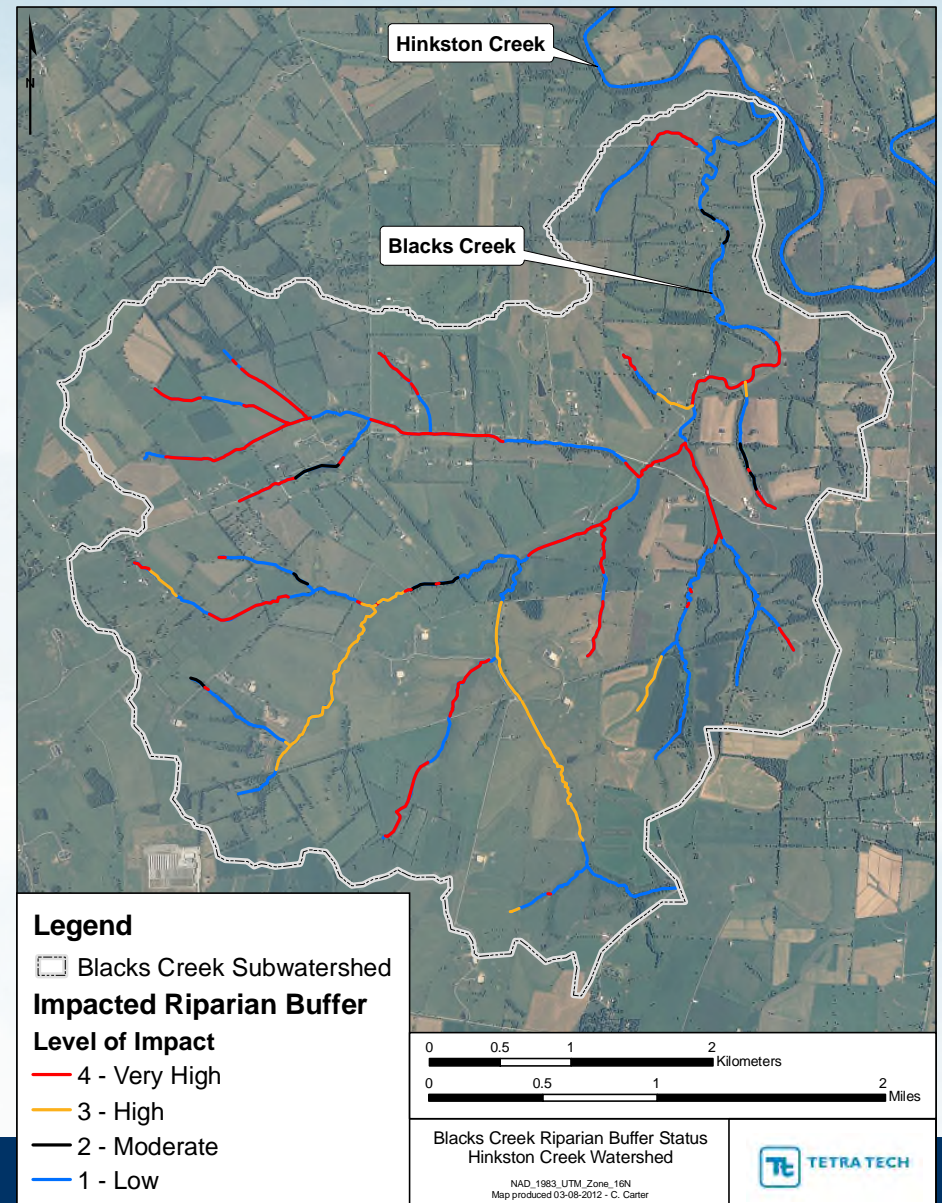
## ► Results – Blacks Creek

- Percent of Very High impact level (Level 4):
  - 33% of total reach length (35km)
- Percent of Low impact level (Level 1):
  - 48%

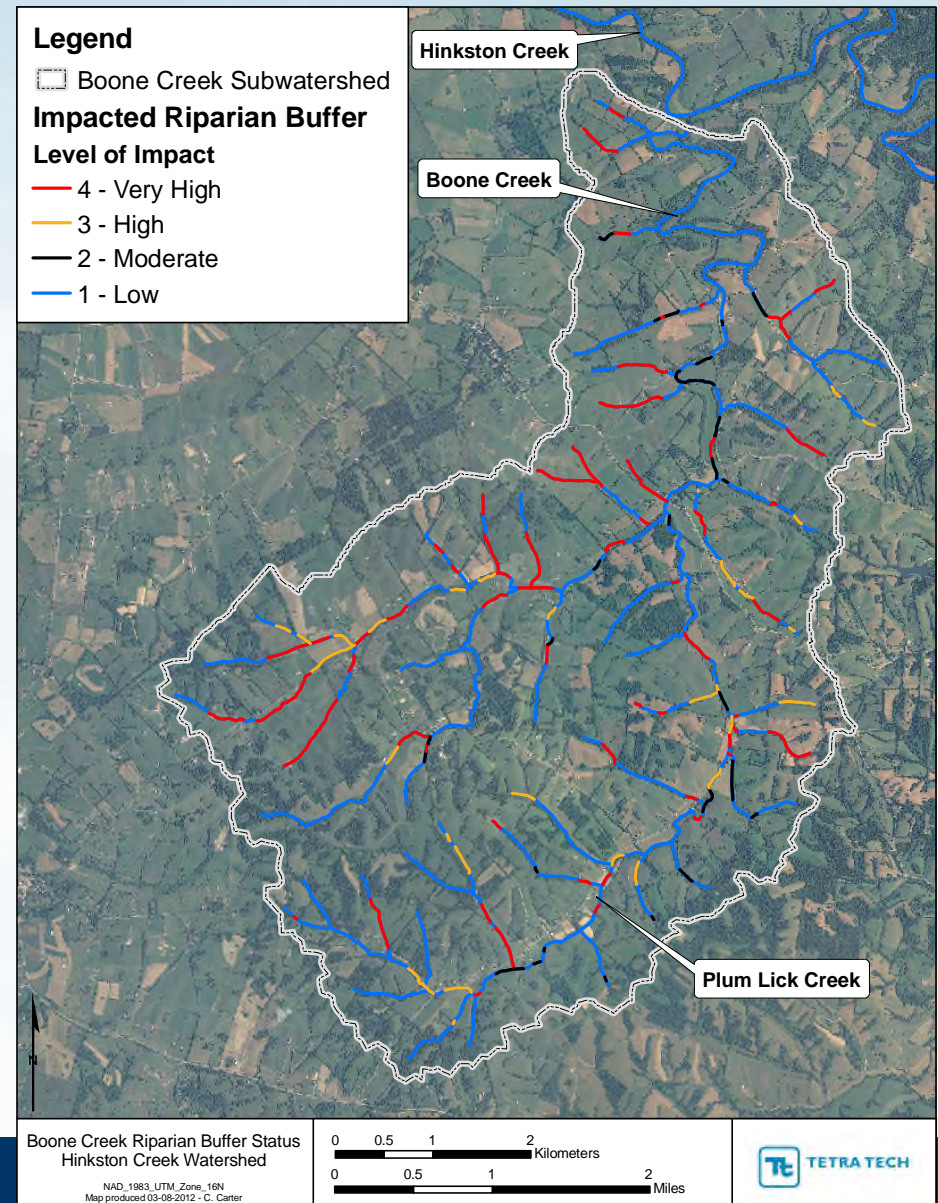
- Results – Boone Creek
  - Percent of Very High impact level (Level 4):
    - 22% of total reach length (74km)
  - Percent of Low impact level (Level 1):
    - 65%
- Identified parcel owners for high-risk areas to support BMP implementation efforts
